NRL/MR/6170--05-8890

# Replacement of Chromium Electroplating on Gas Turbine Engine Components Using Thermal Spray Coatings

July 20, 2005

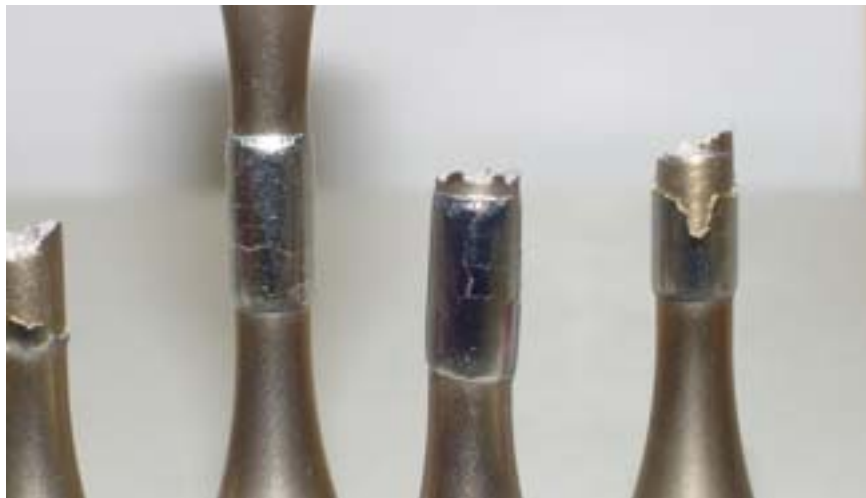
**Figure 4-48 IN-718 Specimens Coated With 0.015" of EHC Following LCF Testing at 750 °F.**

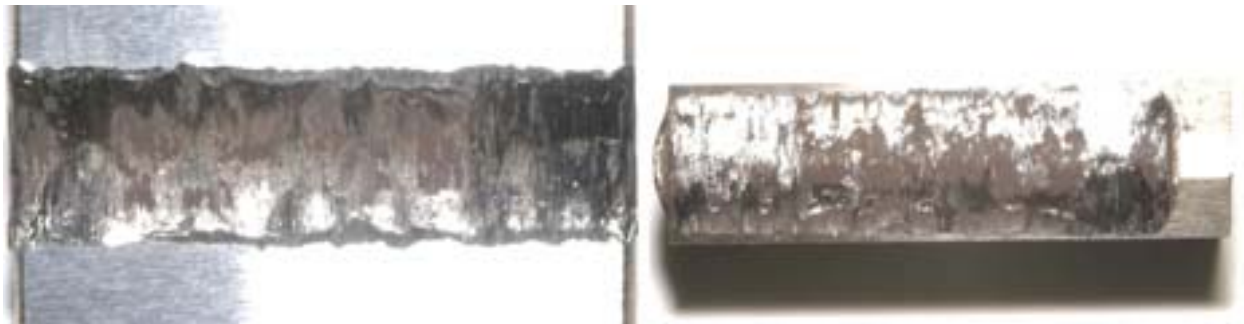
**Figure 4-61 EHC-coated Block (left) and the Mating IN-718 Shoe (right) Following Wear Testing at 300 °F (Test #23)**

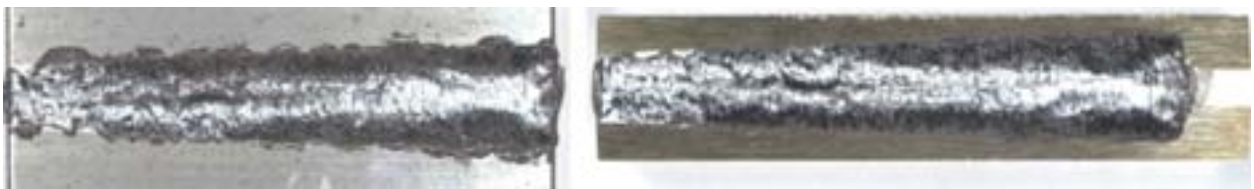
**Figure 4-62 WC/Co-coated Block (left) and the Mating IN-718 Shoe (right) Following Wear Testing at 750 °F (Test #30)**

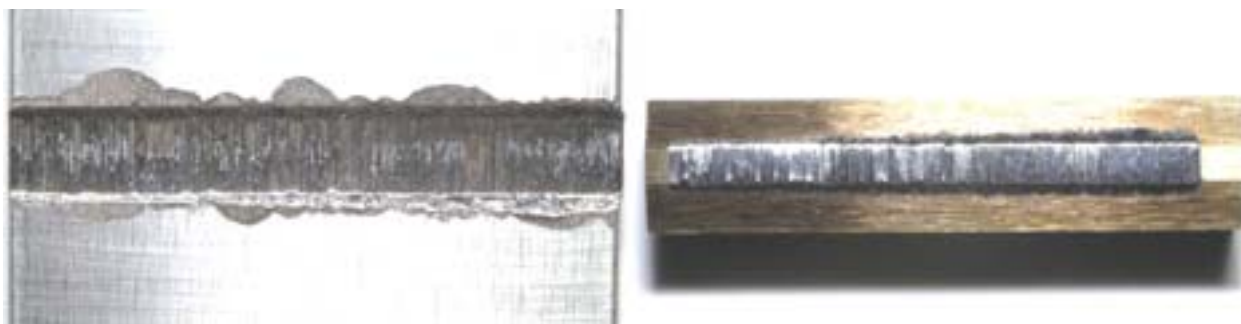
**Figure 4-64  $\text{Cr}_3\text{C}_2/\text{NiCr}$ -coated Block (left) and the Mating M50 Shoe (right) Following Wear Testing at 300 °F (Test #9)**

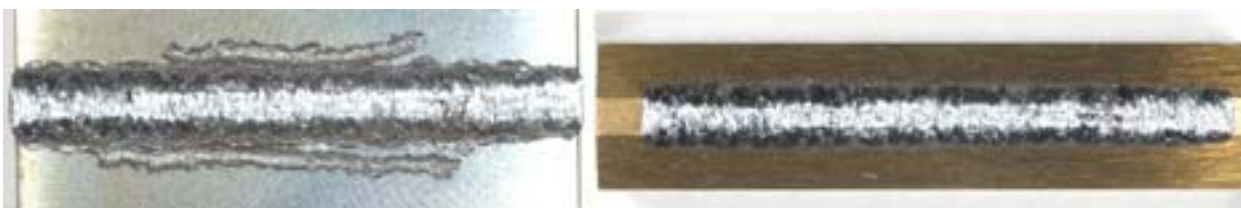
**Figure 4-65 PS T-400-coated Block (left) and the Mating IN-901 Shoe (right) Following Wear Testing at 750 °F (Test #58)**

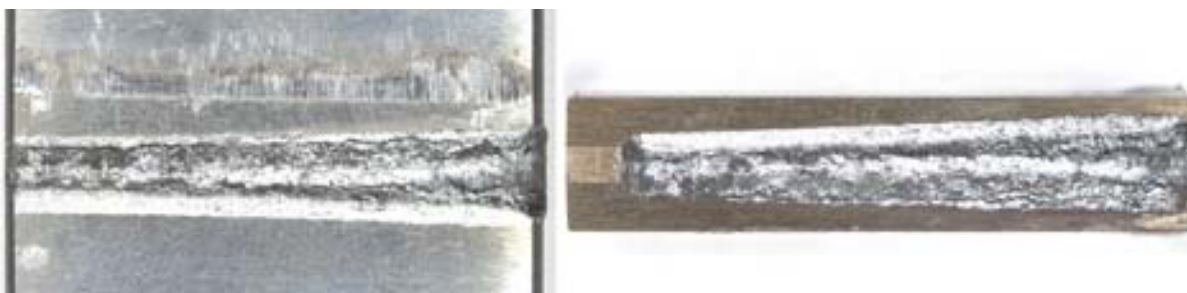
Figure 4-66 shows the EHC-coated block and the mating 17-4PH shoe following wear testing at 750 °F (Test #63). There was moderate wear on both the coating (0.009”) and on the shoe (0.008”) as indicated in Figure 4-58 and Figure 4-59.

**Figure 4-66 EHC-coated Block (left) and the Mating 17-4PH Shoe (right) Following Wear Testing at 750 °F (Test #63)**

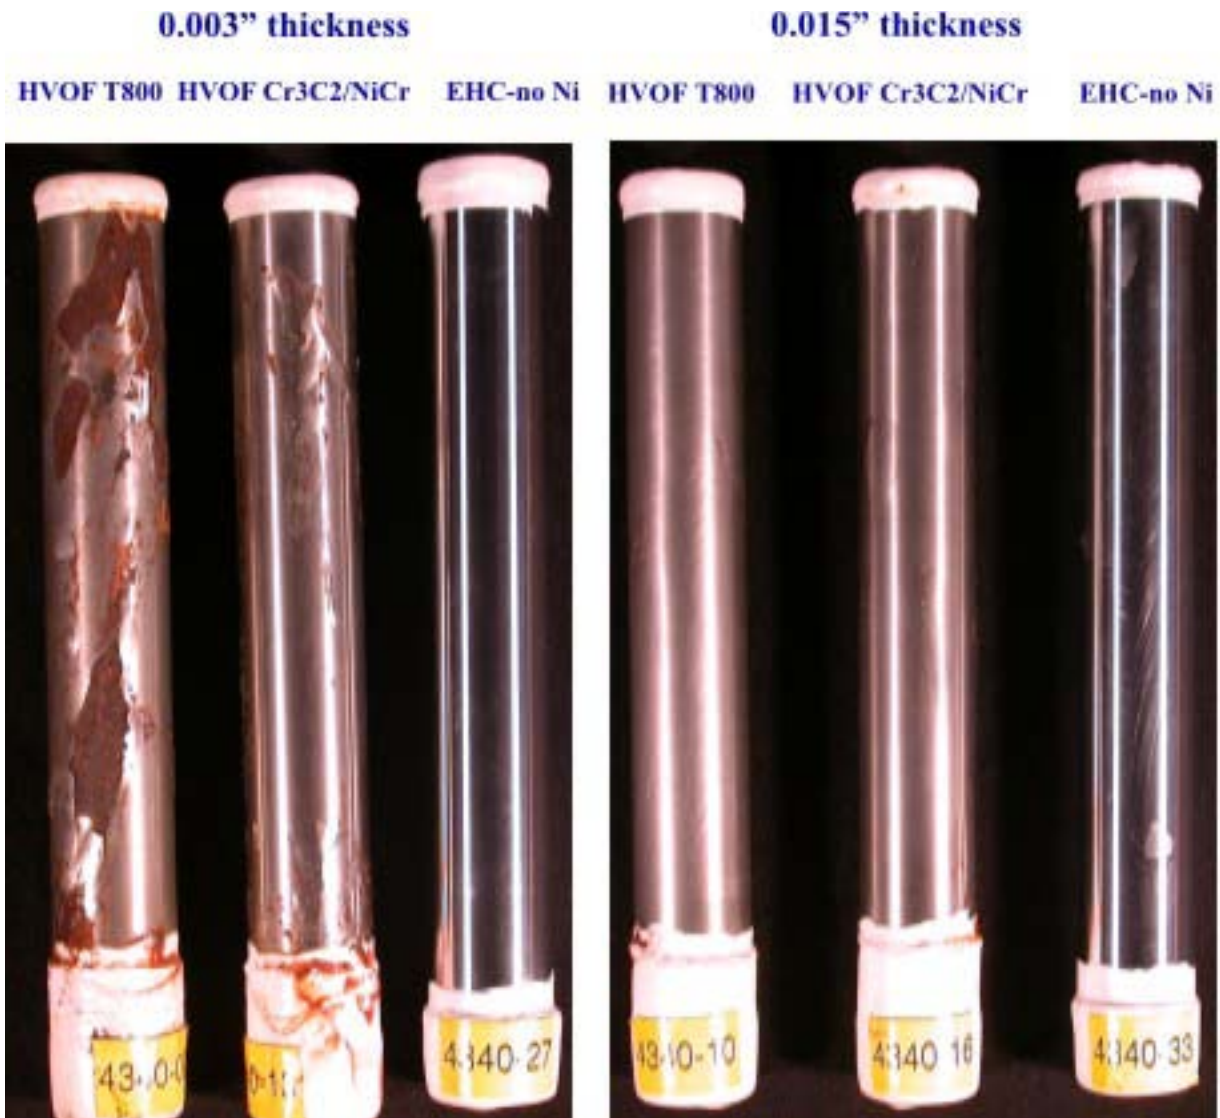
**Figure 4-71 Coated 4340 Steel Rods After 1000 Hours Salt Fog Exposure**

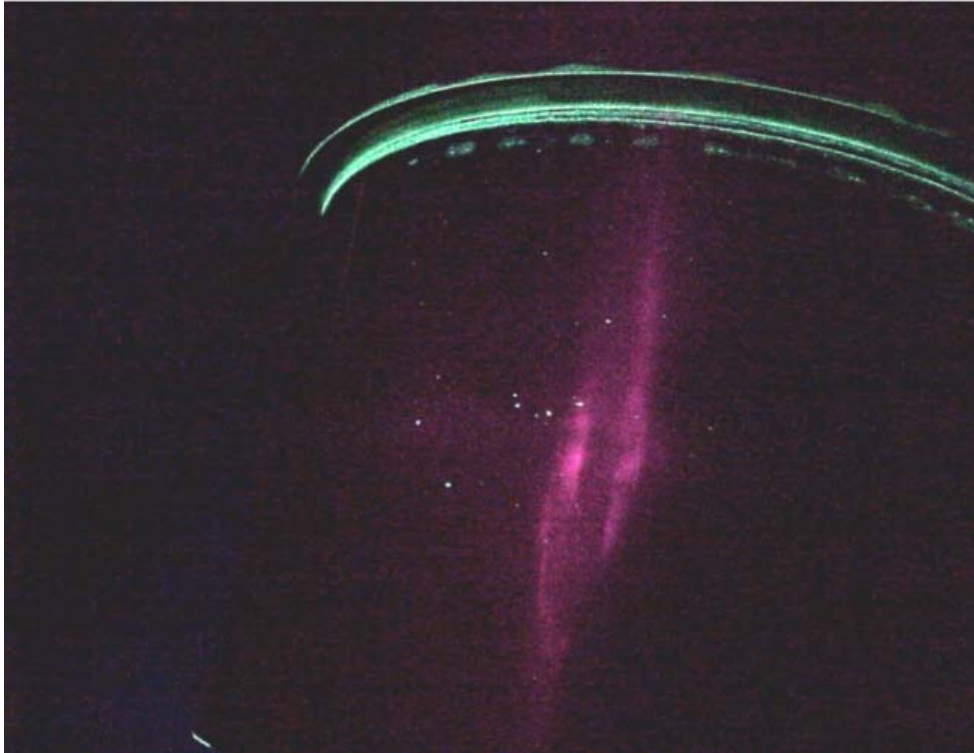
**Figure 5-11 Ultra-High-Sensitivity FPI Indications on No. 2 Bearing Journal on the Front Compressor Rear Hub\**

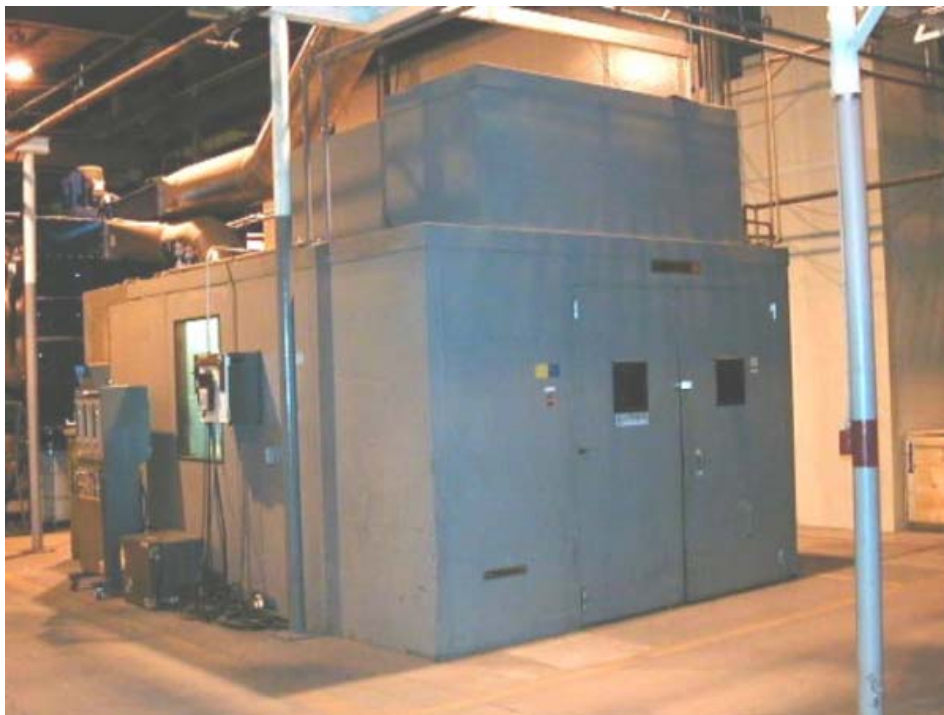
**Figure 7-1 Thermal Spray Booth at OC-ALC**
